**2015 Callide Creek Flood Review  
Public Submission of SunWater Limited**

## CALLIDE CREEK FLOOD REVIEW

Submission by SunWater  
17 April 2015

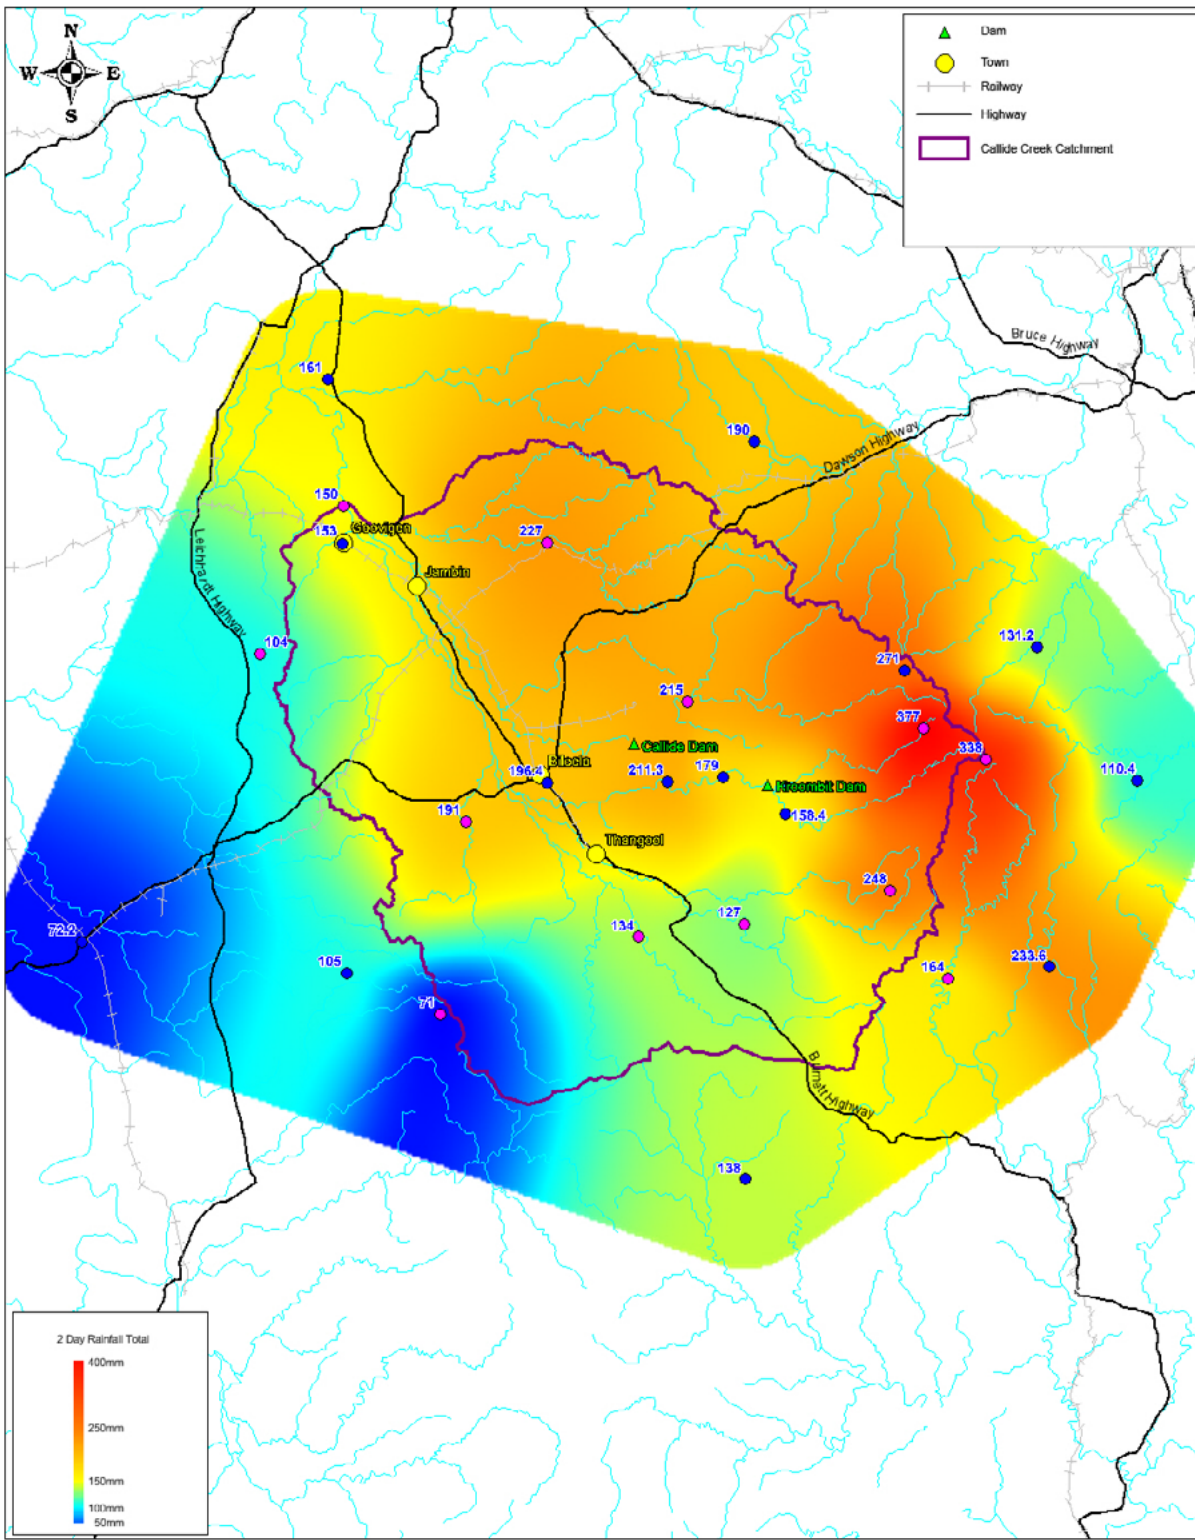
70 **Figure 1** shows the rainfall distribution of 48 hour rainfall totals from 9am on the 19 February 2015 to 9am on 21 February 2015.

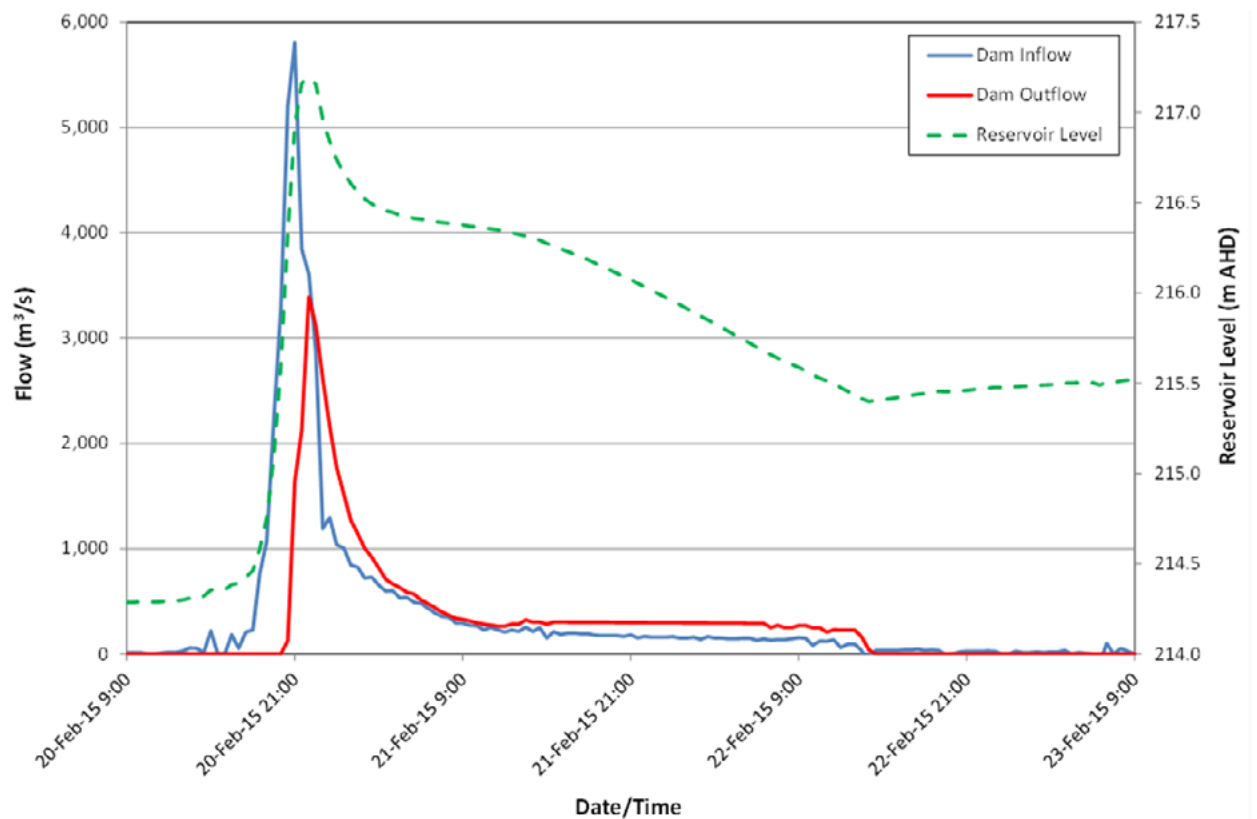
**Figure 2 Estimated Inflows and Outflows – Callide Dam 2015**

- 76 Analysis of the reservoir level and gate opening monitoring data for Callide Dam indicates that a peak inflow to Callide Dam of approximately 5,800 m<sup>3</sup>/s occurred at around 21:00 pm on 20<sup>th</sup> February 2015. Significant attenuation of the flood through the dam resulted in a peak discharge from the dam of around 3,400m<sup>3</sup>/s at 22:00 on 20<sup>th</sup> February 2015. This is evident from **Figure 2**, which demonstrates the estimated inflows and outflows from Callide Dam.

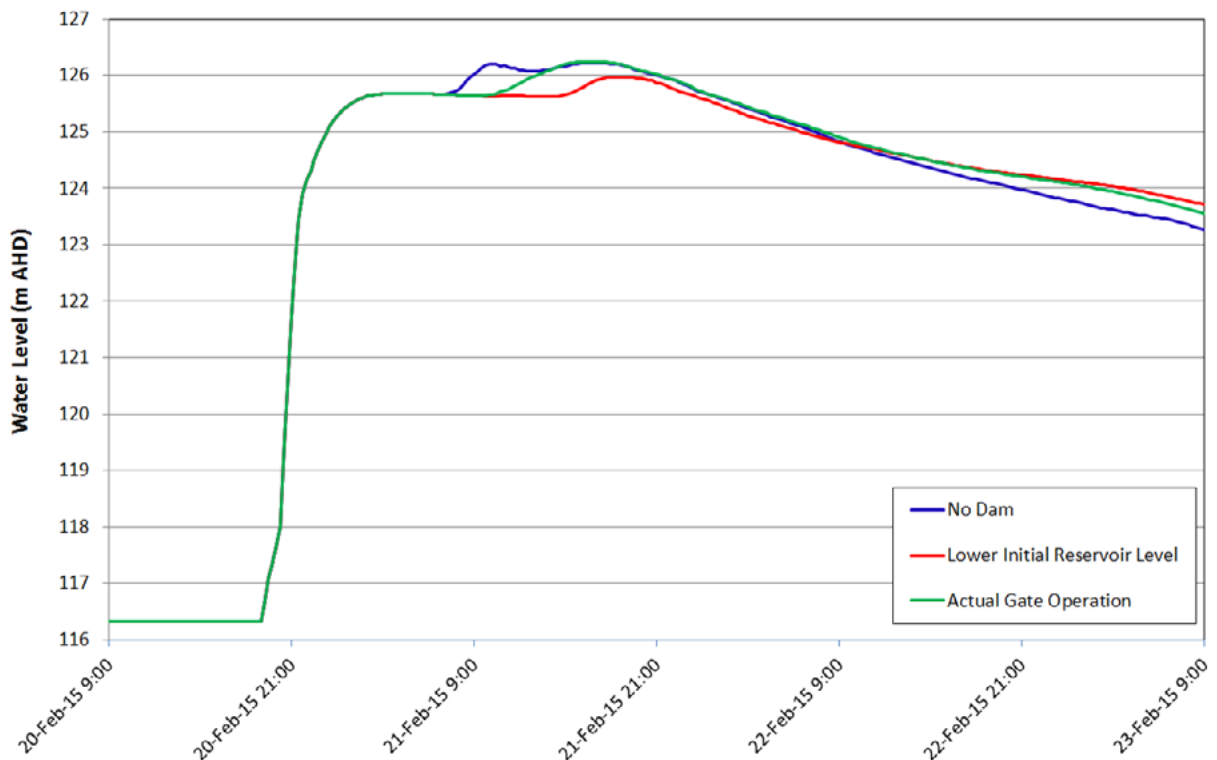
**Figure 3 – Flood levels at Goovigen Township for three scenarios**

- 102 The actual and lowered scenarios are almost identical until about 10am on 21 February 2015 confirming that flood levels at Goovigen to this point in time were unaffected by water from Callide Dam catchment.
- 103 If the dam commenced the flood event at the fixed spillway crest level (which was not permitted, as explained above), the maximum benefit at Goovigen would have been a lowering of the second flood peak at Goovigen of around 250mm.
- 104 If the dam had not been in place at all, the event at Goovigen would have been a triple-peaked event with an additional peak at 10:00 on 21 February 2015 as discharge from Callide Dam arrived.

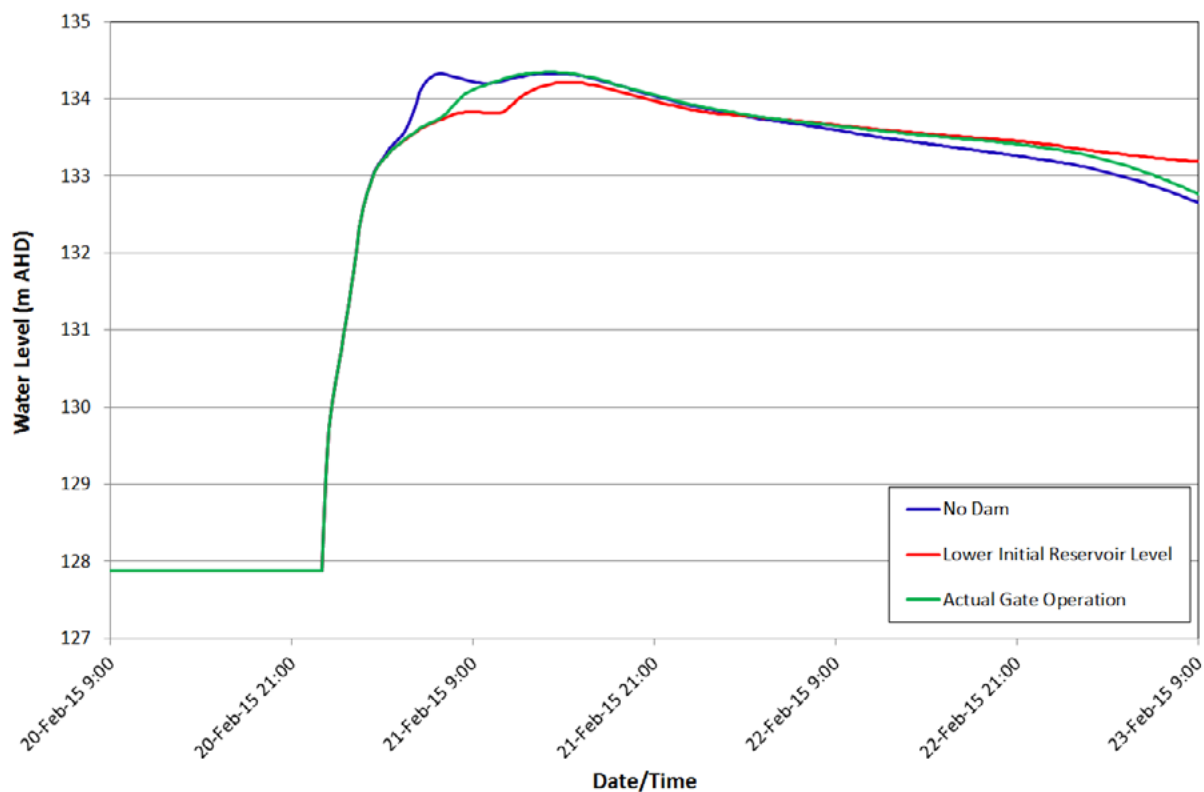
**Figure 4 – Flood levels at Jambin for three scenarios**

- 105 As no gauge exists at Jambin, modelling was used to estimate flood heights.
- 106 Rising flood levels at Jambin were initially caused by local tributaries and inflows such as Oaky Creek. The initial and rapid rise from local tributaries occurred well prior to water arriving from the Callide, Kroombit, Kariboe and Grevillea Creek systems.
- 107 The no dam scenario, also shown in **Figure 4**, indicates that significant benefit was provided at Jambin in terms of flood attenuation.
- 108 If the dam commenced the flood event at the fixed spillway crest level (which was not permitted, as explained above), the maximum benefit at Jambin would have been a lowering of the flood peak by about 130mm.

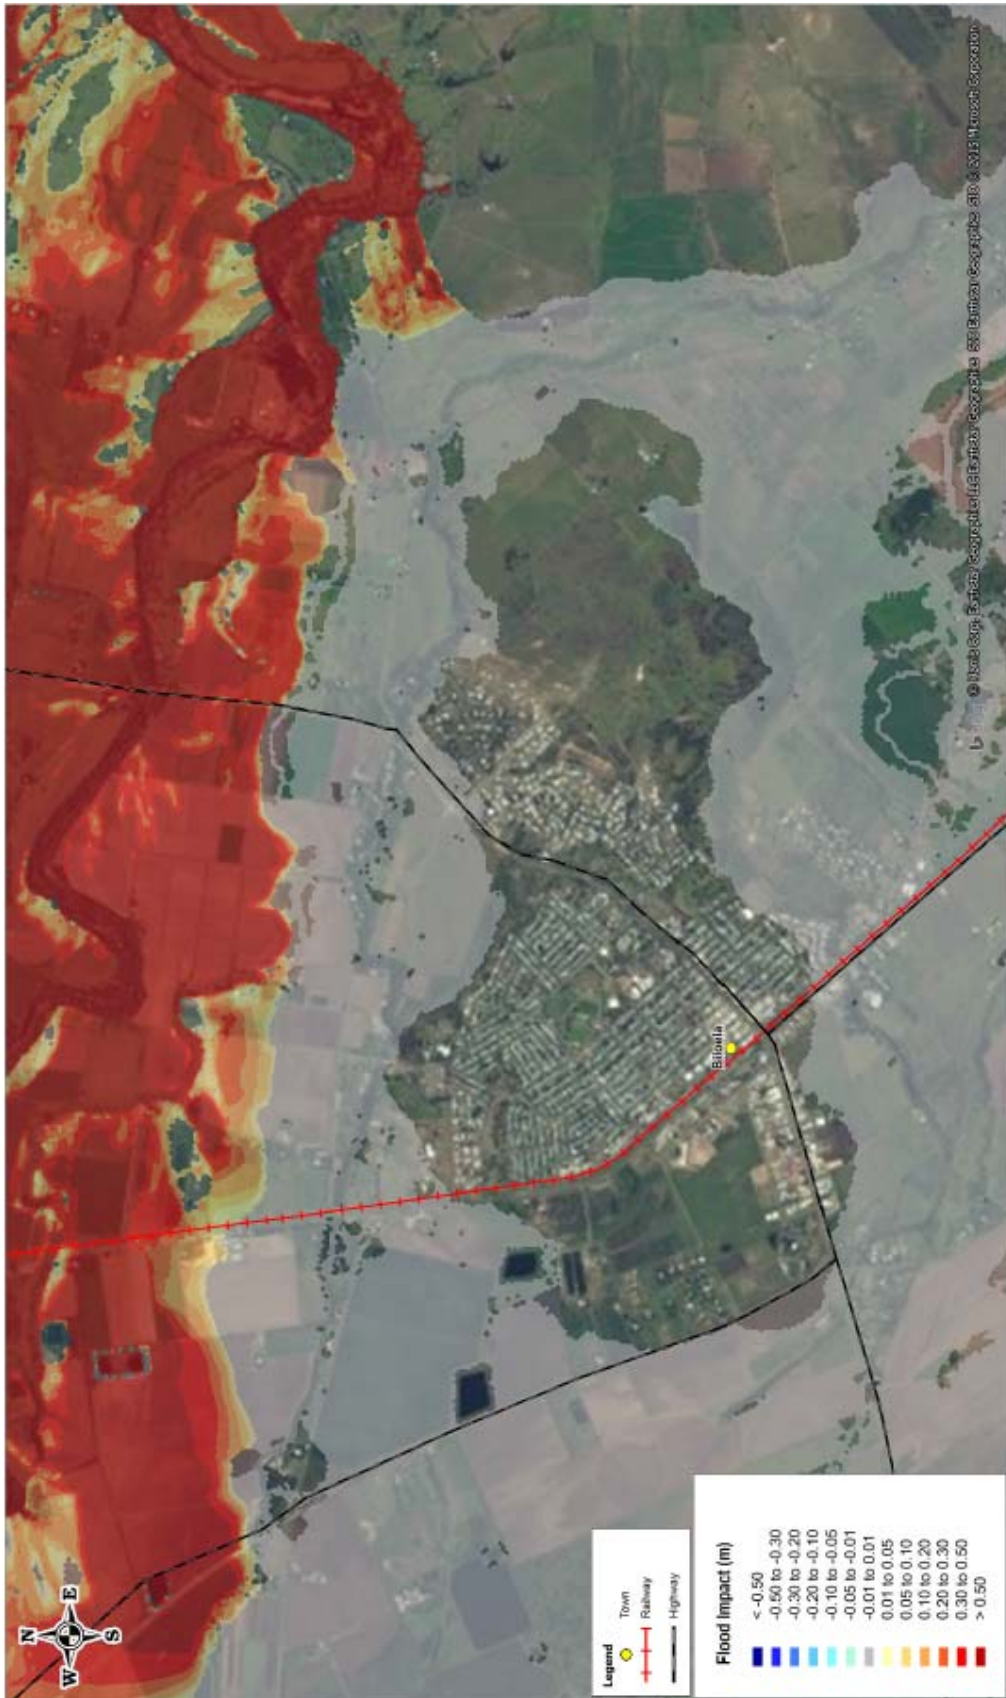
**Figure 5**  
**Callide Dam February 2015 Event**  
**Predicted February 2015 Flood Impacts**  
**Actual Operation vs Lower IWL Dam**

- 111 The grey area shows where there was no difference in peak flood levels between what actually occurred and the hypothetical scenario. This means that the peak flood levels around Biloela were not attributable to flows from Callide Dam but rather were attributable to Kroombit Creek.

- 112 In summary, peak flood levels in the vicinity of Biloela during the February 2015 flood event were a result of Kroombit Creek discharges and the discharge from Callide Dam made negligible (less than 1cm) difference to the flood peak in the immediate vicinity of Biloela.

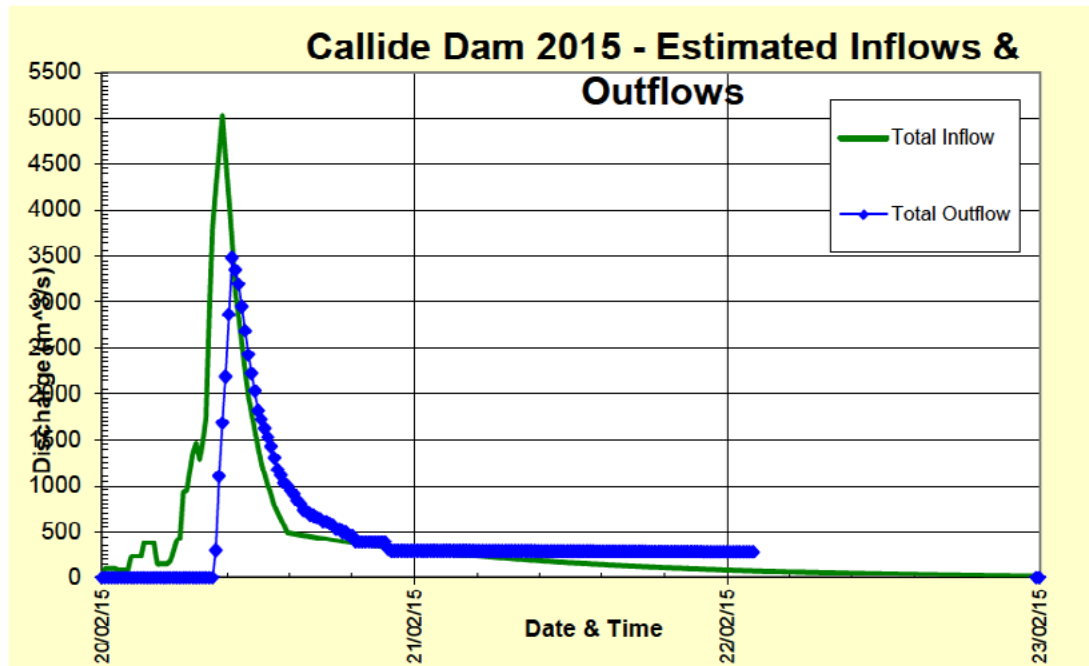
The storage level peaked at 22:00 at a level of 217.19m. This was also the time of maximum gate opening with the centre gates 7.0m open and outer gates 6.0m open. The estimated peak discharge was 3,480m<sup>3</sup>/s.
