# Paradise Dam Preparedness Review

Report 1: 2019-20

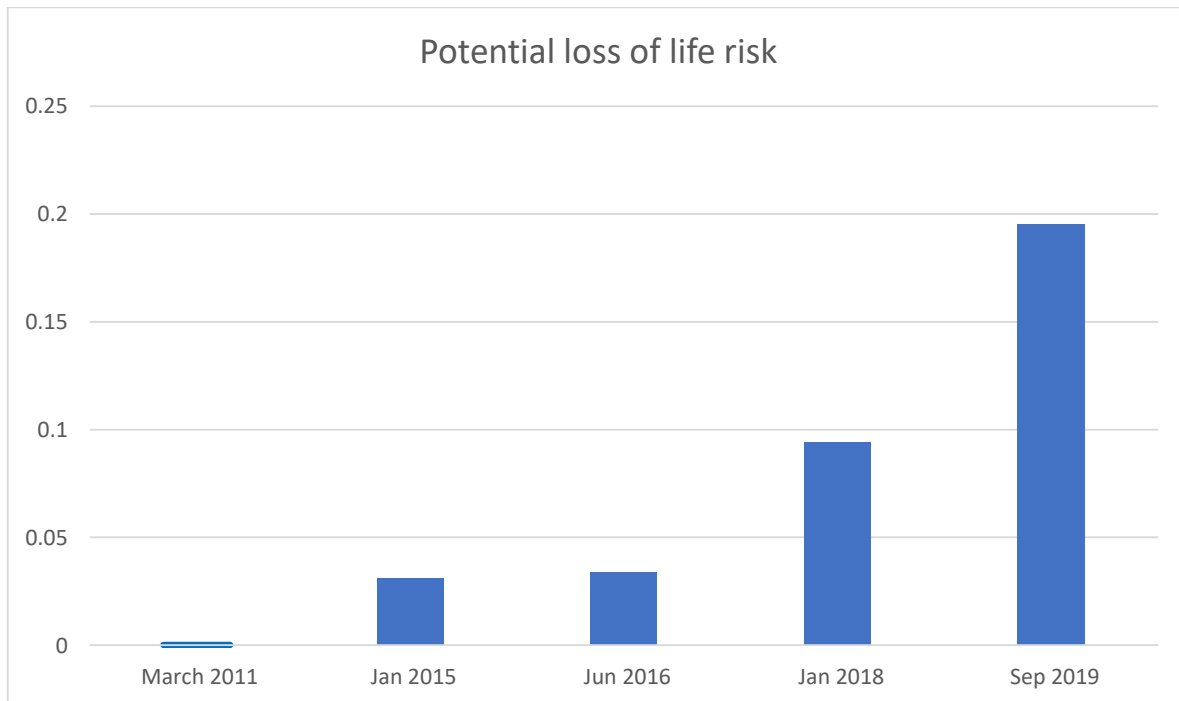
the calculated risk to life has grown significantly, 6-fold between January 2015 and September 2019 and 1500-fold between March 2011 and September 2019.

**Figure 1: Graph showing the change of potential loss of life probability over time**

This information has been calculated by the dam operator for this particular dam, but is not available to disaster management planners. When these figures are graphed (see Figure 1),

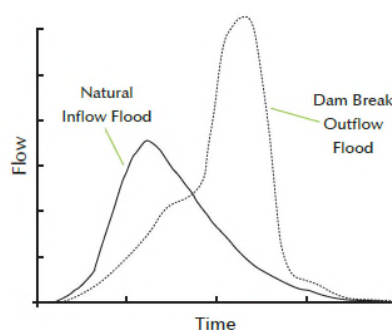
Figure 3b

Dams may also have the potential to fail and the subsequent dam-break floods can cause substantial damage downstream. The effect of dam failure on flood flows is illustrated in Figure 3b. Dam-failure floods involving a risk to life are rare events, but failure usually causes extremely rapid rises in downstream flood levels and often these rises occur with little or no effective warning especially if the population at risk is close to the dam.<sup>70</sup>
